2014

FINAL STEWARDSHIP PLANS

Fort Folly Habitat Recovery

Petitcodiac Watershed Alliance

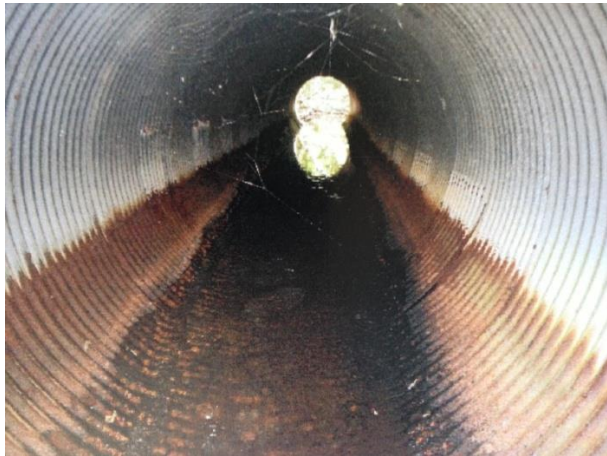
Culvert AJ10 (Figure 1-5) is located on Albert Mines Road and was last inspected on July 18, 2012. The overall structure condition is designated as FAIR. The following recommendations were made for this culvert:

Figure 1-5: Culvert AJ10.

- The vegetation on both sides of the road should be removed
- The debris and vegetation in the waterway and inside the pipe should be removed
- The gabions of rocks at both ends of the culvert should be replaced
- The wheel ruts, depressions, transversal cracks and pot holes should be repaired

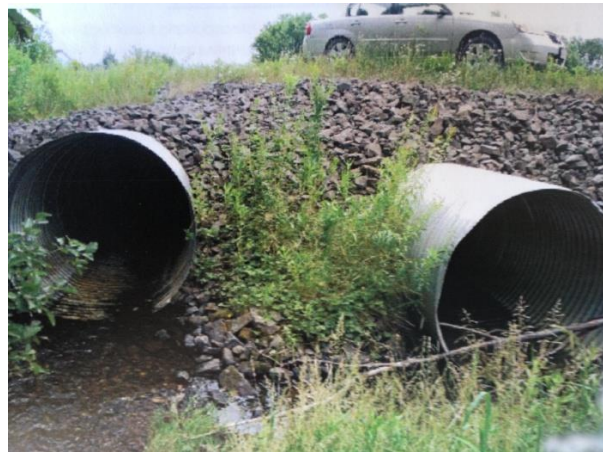
Culvert AJ11 (Figure 1-6) is located on Albert Mines Road and was last inspected on July 18, 2012. The overall structure condition is designated as EXCELLENT. The following recommendations were made for this culvert:

Figure 1-6: Culvert AJ11.

- The vegetation on both sides of the road should be removed
- The debris and vegetation in the waterway should be removed
- The scouring hole at the downstream end of the culvert should be eliminated

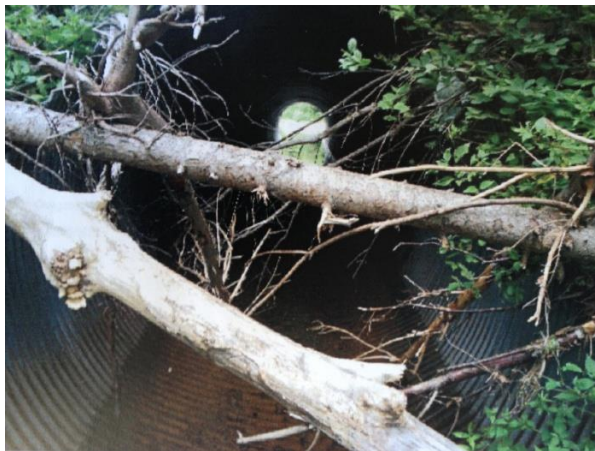
Culvert AJ12 (Figure 1-7) is located on Albert Mines Road and was last inspected on July 18, 2012. The overall structure condition is designated as FAIR. The following recommendations were made for this culvert:

Figure 1-7: Culvert AJ12.

- The vegetation on both sides of the road should be removed
- The debris and vegetation in the waterway should be removed
- The wheel ruts, transversal cracks and cracks going in all directions should be repaired
- The scouring hole should be eliminated

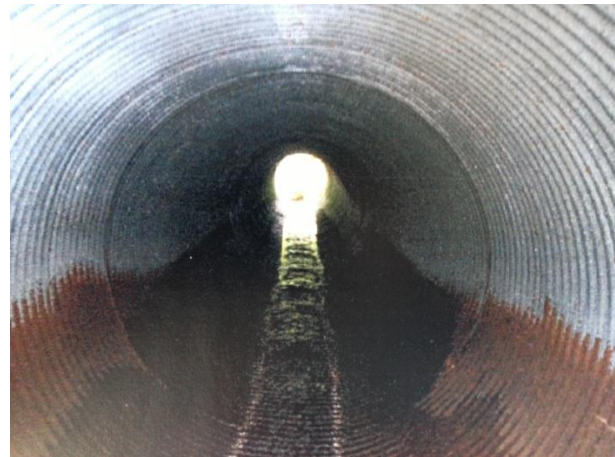
Figure 1-8 : Culvert AJ13.

Culvert AJ13 (Figure 1-8) is located on Albert Mines Road and was last inspected on July 18, 2012. The overall structure condition is designated as FAIR. The following recommendations were made for this culvert:

- The vegetation on both sides of the road should be removed
- The debris and vegetation in the waterway should be removed
- The scouring hole should be eliminated
- The wheel ruts, depression, transversal cracks and cracks going in all directions should be repaired
- The undermining at both ends should be stopped and repaired
- The erosion at the upstream end of the culvert should be stopped and repaired

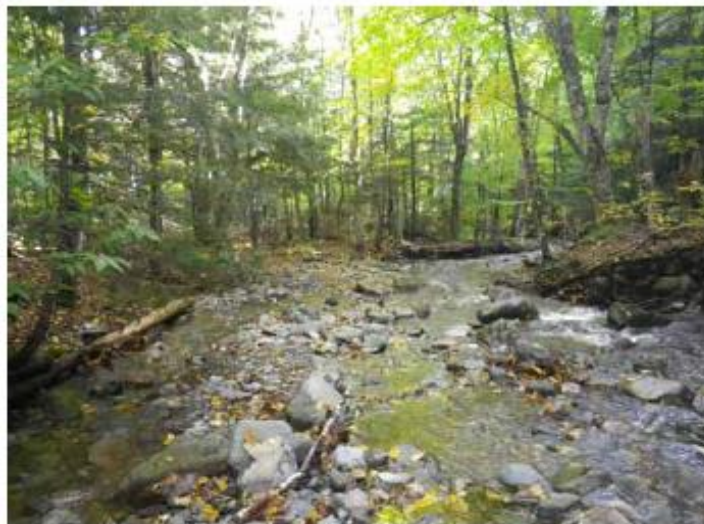
Figure 1-11: Channel widening on Demoiselle Creek.

The upper reach of Demoiselle Creek shows evidence of planform adjustment, which is likely related to the channel widening process occurring along 5 sub-reaches (Figure 1-11). As the streambed widens, the channel can migrate laterally.

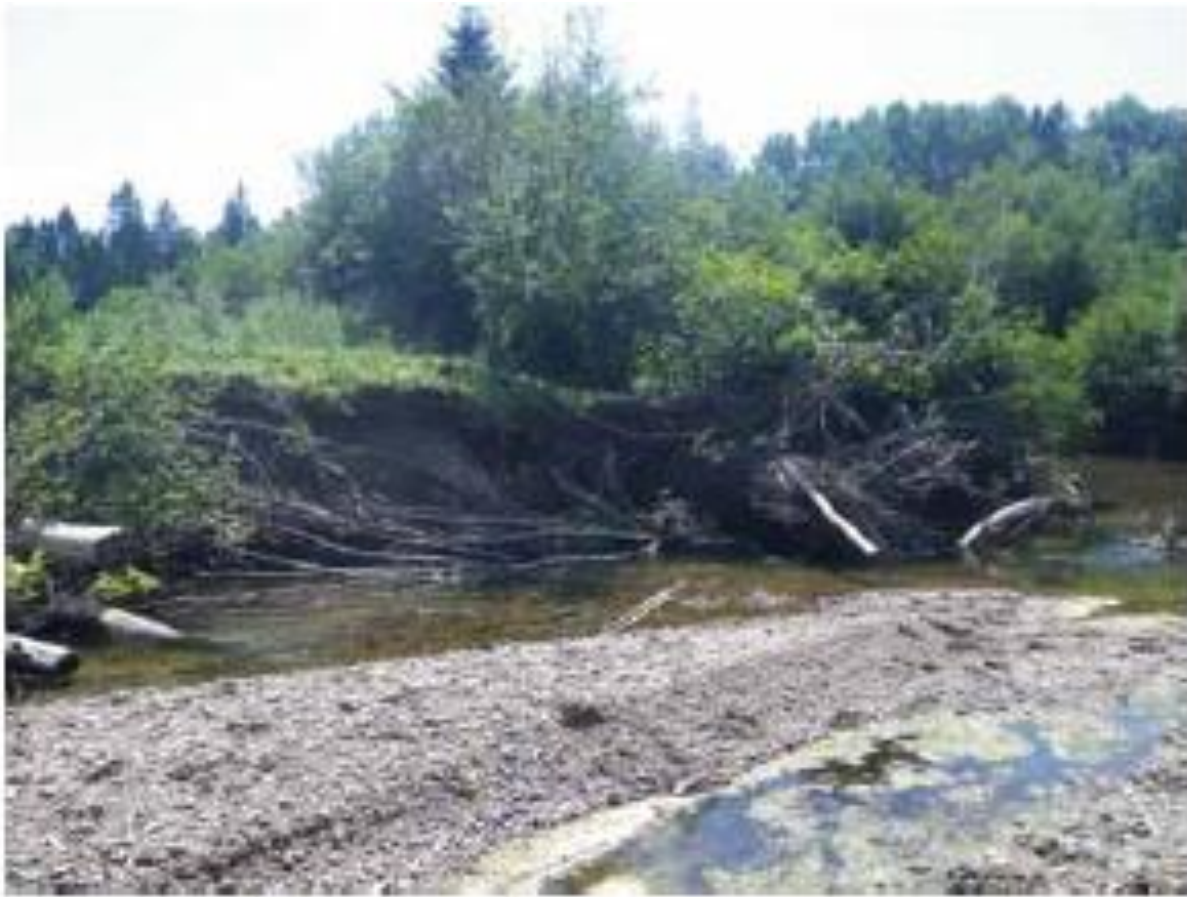
The lower reach of the stream has a lower gradient than the upper reach and it flows through various farmlands. Erosion is occurring along stretches where the vegetation buffer has been removed and turned into farm fields. The result is increased sediment loads and channel widening, which shows that widening is the dominant geomorphic process in the lower portion of the lower reach. An example of erosion and channel widening as the stream flows through farmland is shown in Figure 1-14.

Figure 1-14: Degradation (bank erosion) and channel widening on Demoiselle Creek.

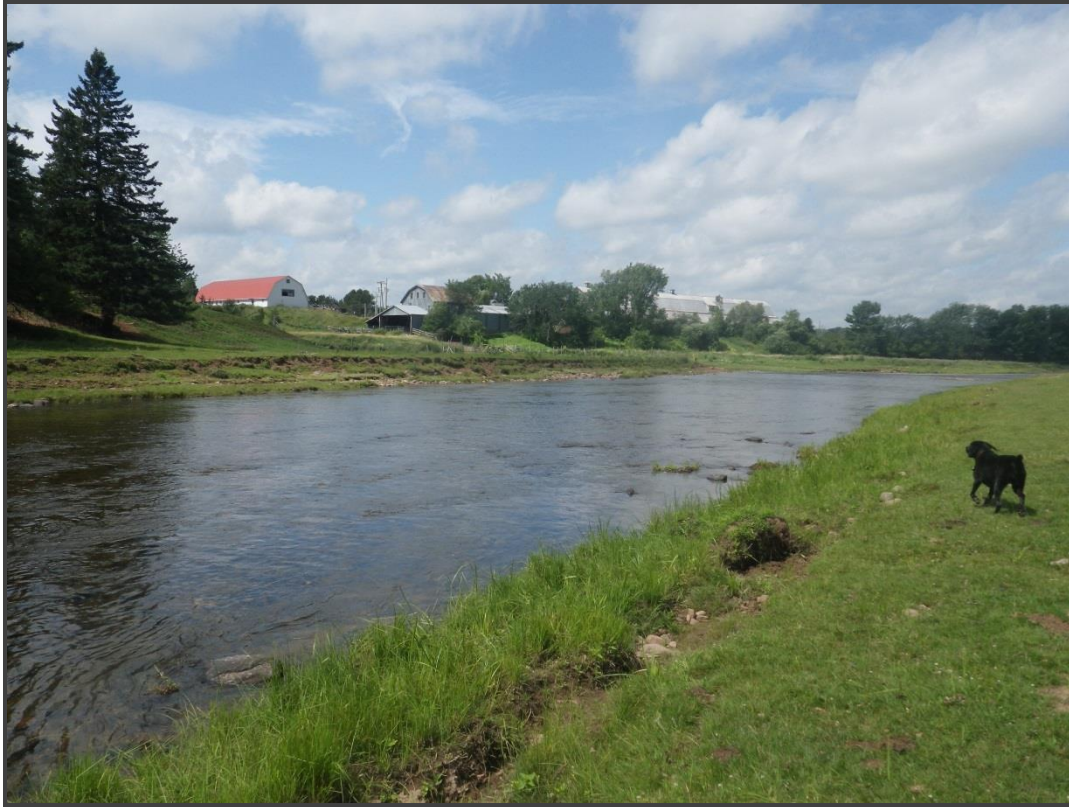
Figure 2-10: Photo of active cattle pasture along floodplain of LR 83

access to the river with predictable consequences (Figure 2-10). Row crops and grains predominate across the watershed, representing about 75% of the agricultural activity (Department of Natural Resources 2014). The rest is divided nearly evenly between blueberry fields 12 % and pastureland 13%. The blueberry fields are concentrated at higher elevation in the remote upper reaches of the watershed, while pastureland, row crops and grains are distributed throughout at lower elevations along the valley floor, with the latter particularly concentrated within about a 2 km radius near and below Colpitts Settlement.

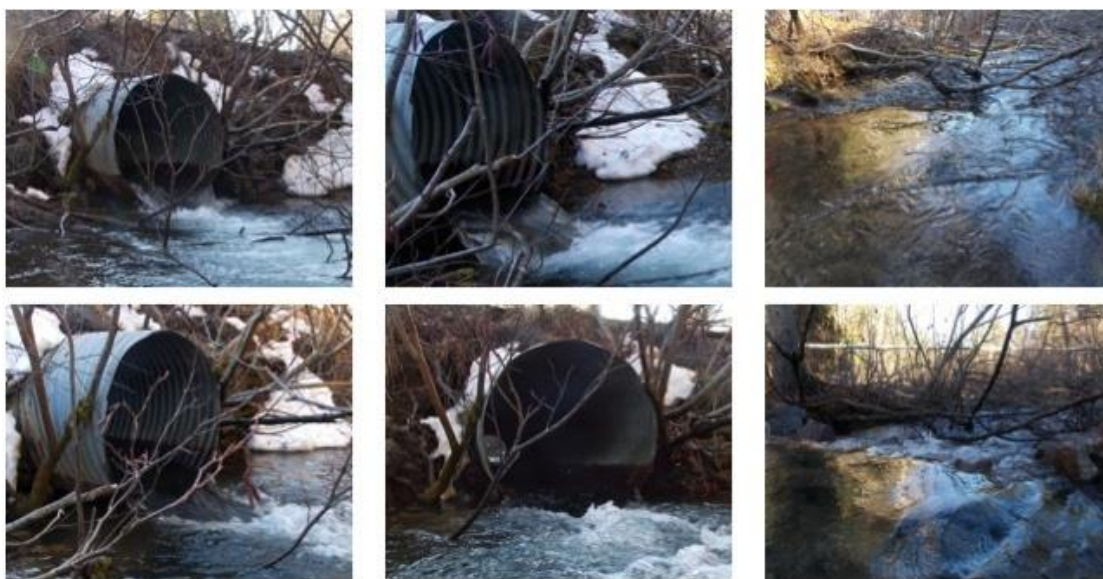
Figure 2-15: Outflow photos of culvert C051 before and after construction of a vortex rock weir downstream.

Gradual reduction of the outflow drop was visible during rock weir construction. Comparison of before and after outflow drop photos below show that the outflow drop was successfully reduced.

Over time, the watercourse will naturally deposit material within the rock weir and fortify the structure. Stream-crossing structures should be inspected and maintained on a regular basis, especially following high water flow season and large rainfall events. Installing this rock weir allowed fish access to approximately 2.5 km in length and 6.03 km² of upstream habitat.

In 2014 the work done with culverts on the Little River found 4 that were partial barriers and 10 that were full barriers to fish passage. Of these, 1 of the full barrier culverts has already been addressed (Figure 2-15) through the work described above. The remaining 13 should be ranked in order to prioritize them (by factors such as complexity of repair (due to either technical or landowner issues), upstream habitat made accessible, etc.). Then starting with those where action is most practical & beneficial they should be modified as needed to improve passage.

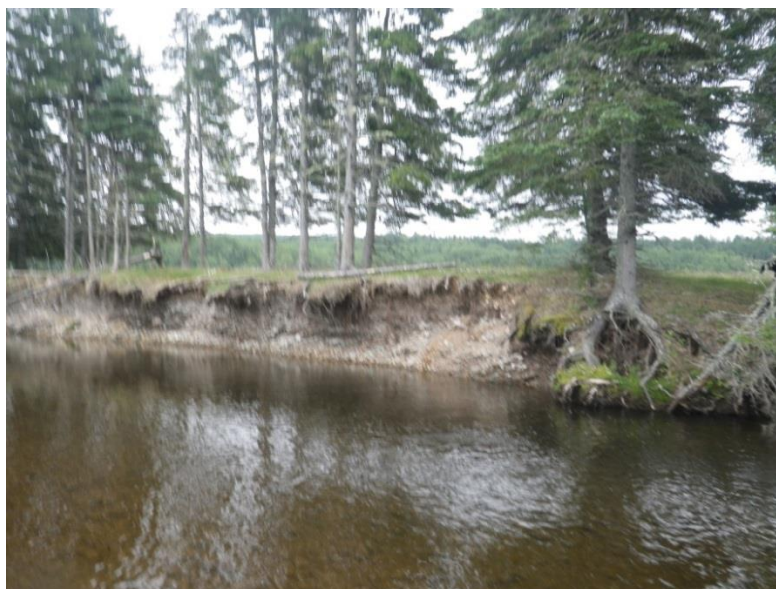
David and Marilyn Mitton have expressed a desire for help with stream bank stabilization in order to protect part of the pasture of their cattle farm, in the community of Meadow on the Little River, downstream of its confluence of the East Branch Little River, Figure 2-16.

Figure 2-16: Mitton Farm's unstable bank

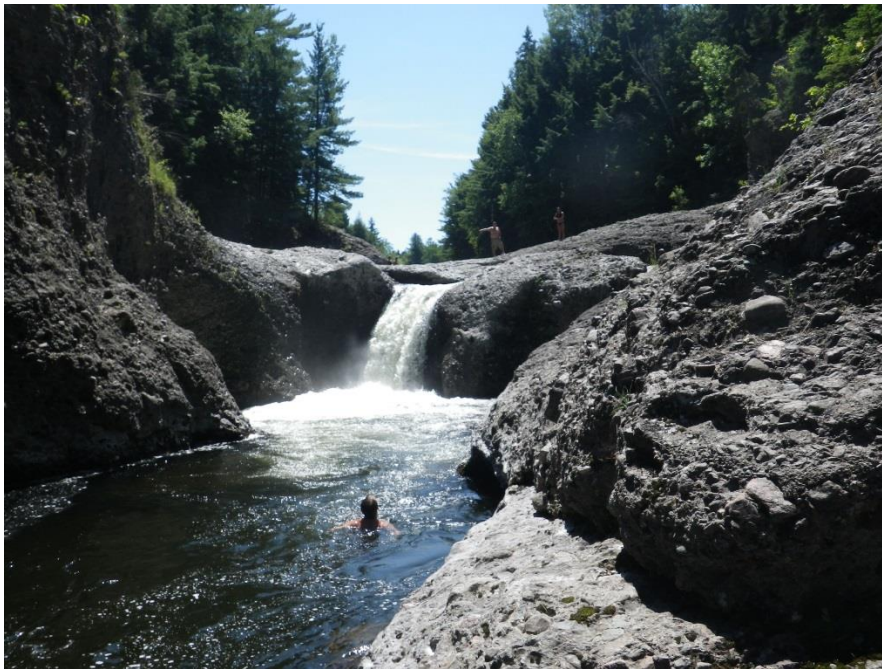
Figure 3-2: Gordon Falls upstream of Elgin

In its upper reaches the Pollett flows through a steep valley covered with mixed conifer and deciduous forest and is separated from the lower reaches by a deep gorge over a kilometer long. Gordon Falls (Figure 2) located near the midpoint along the gorge, drops 4.5 to 6 meters depending upon the level of flow in the river. Below the gorge from Elgin to its mouth the river is fairly consistent, with a gradient of about 3 meters per kilometer. It forms a series of shallow pools that alternate with long gentle rapids, flowing through stretches of forest broken up occasionally by scattered farmland and camps, that become increasingly frequent the closer to the mouth one gets.

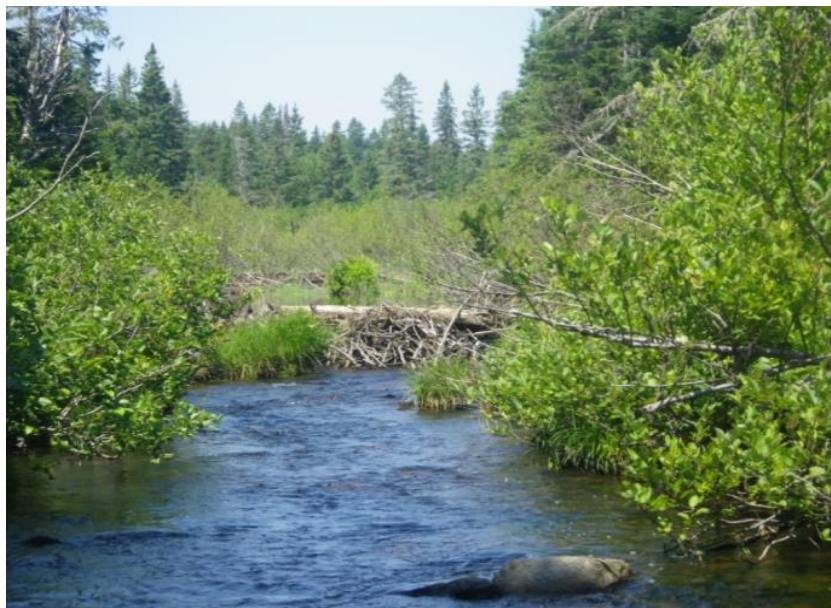
Figure 3-19: Beaver dam along Reach 1 at sub-reach MLB 2 19

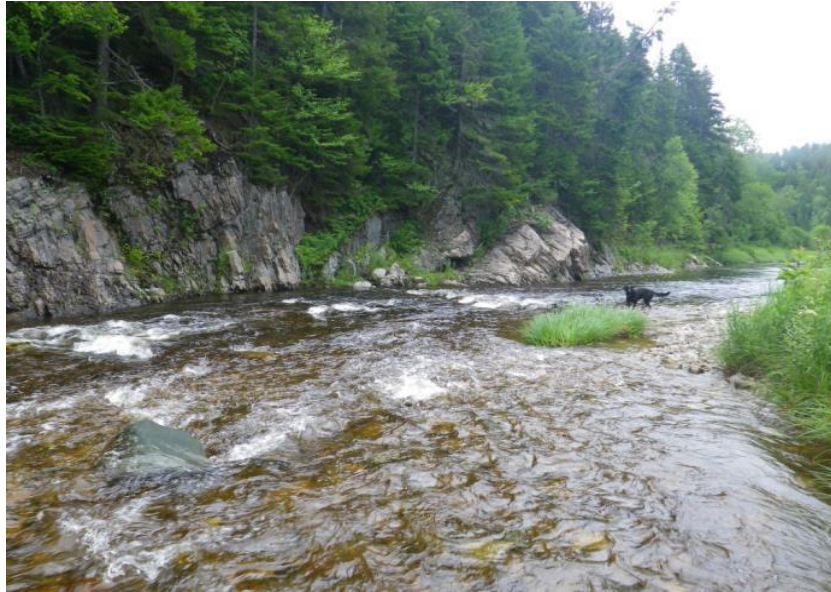
Figure 3-23: Exposed bedrock on left bank in Reach 2 (sub-reach PS 3 10)

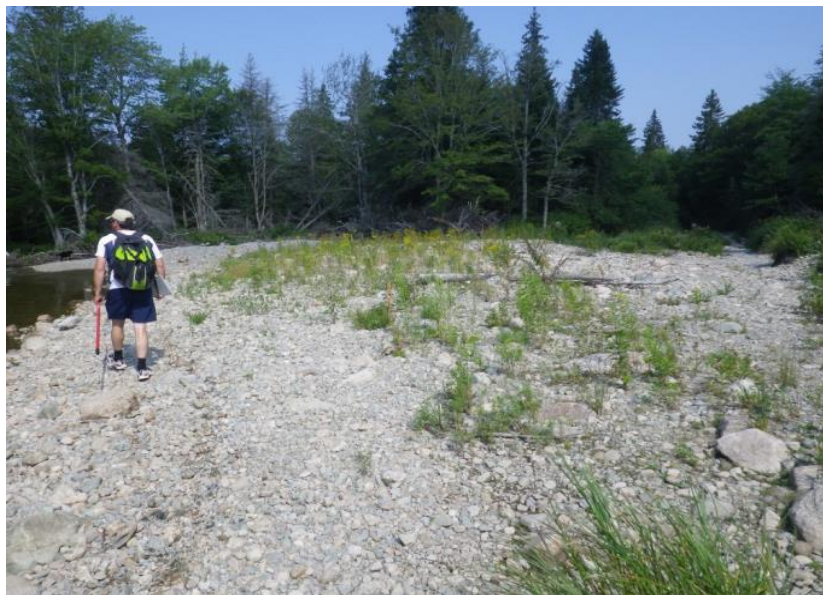
Figure 3-24: Large depositional feature in Reach 2 (sub-reach PS 3 36)

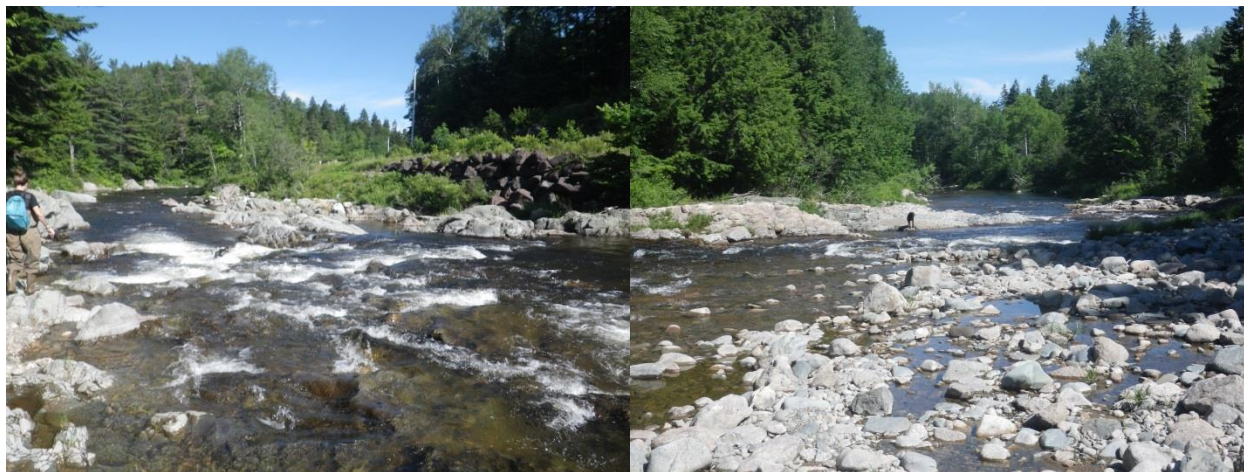
Figure 3-26: Rapids in Reach 2: sub-reach PS 2 14 (left); and sub-reach PS 2 17 (right)

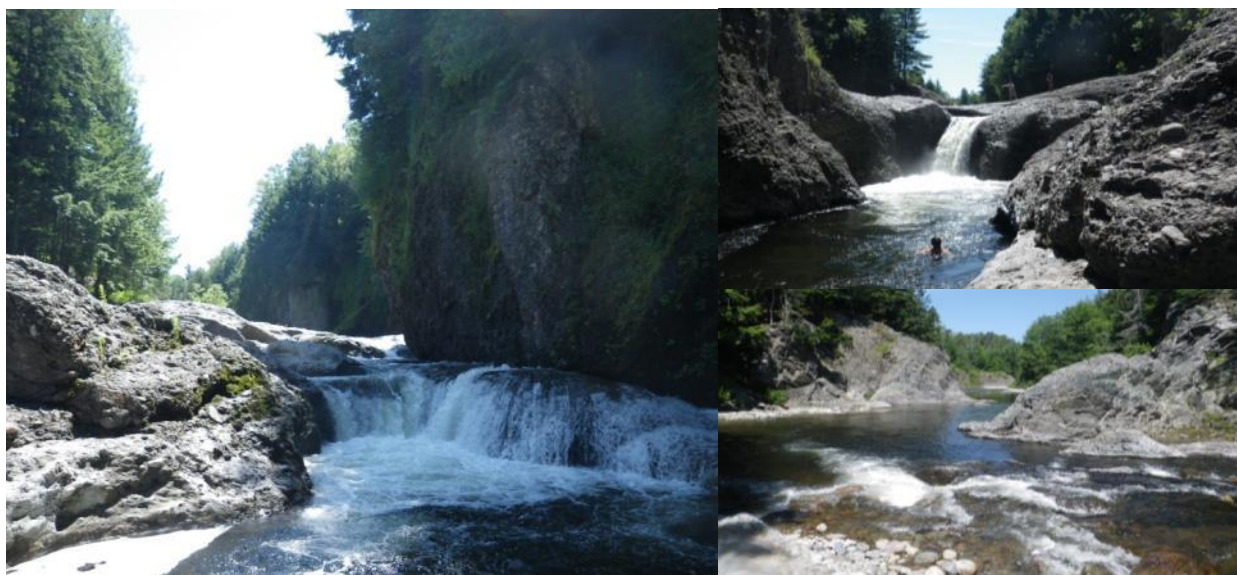
Figure 3-27: Rapids and waterfalls in Reach 2: sub-reach PS 2 21 (bottom right); sub-reach PS 2 23 (top right); and sub-reach PS 2 24 (left)

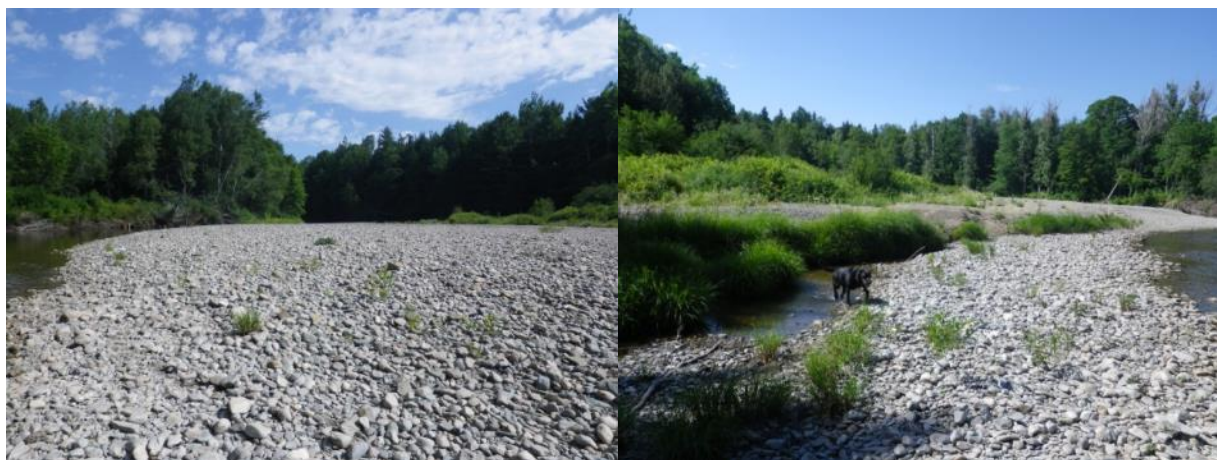
Figure 3-31: Aggradation in Reach 3 (sub-reach 3 31)

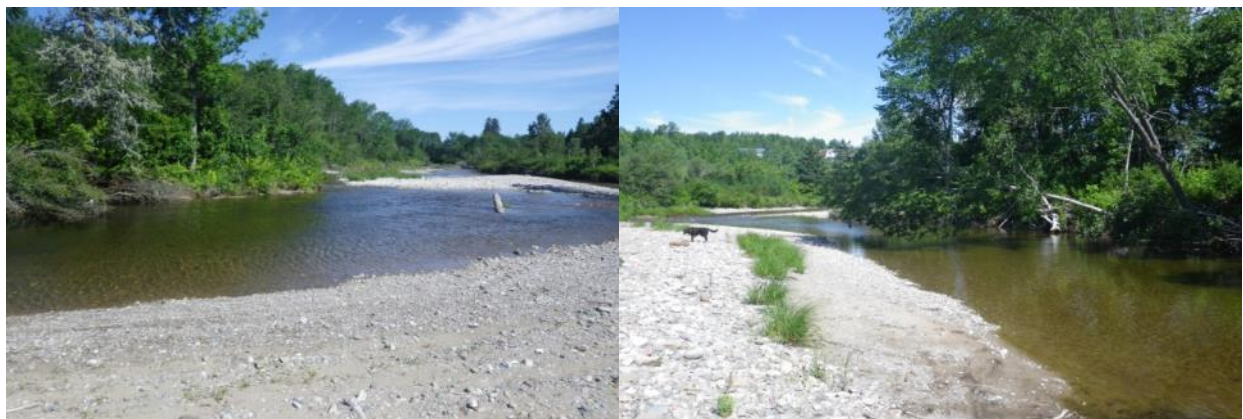
Figure 3-32: Aggradation in Reach 3 (subreach PS 3 34)

The lower sub-reaches of this section, downstream of the waterfalls, are accessible by salmon, and thus warrant higher priority for work than those above them. These reaches are mostly experiencing instability due to an increase in the bedload as illustrated in Figure 3-31 and Figure 3-32. Restoration efforts should focus on locating the source of the sediment and implementation of strategies such as re-establishment of vegetation via changing land use practises, or bank treatments such as seeding, planting, or possibly slope regrading if banks are severely eroded. Given the large number of land owners in and around Elgin, significant outreach is necessary to identify individuals interested in and capable of undertaking such projects.

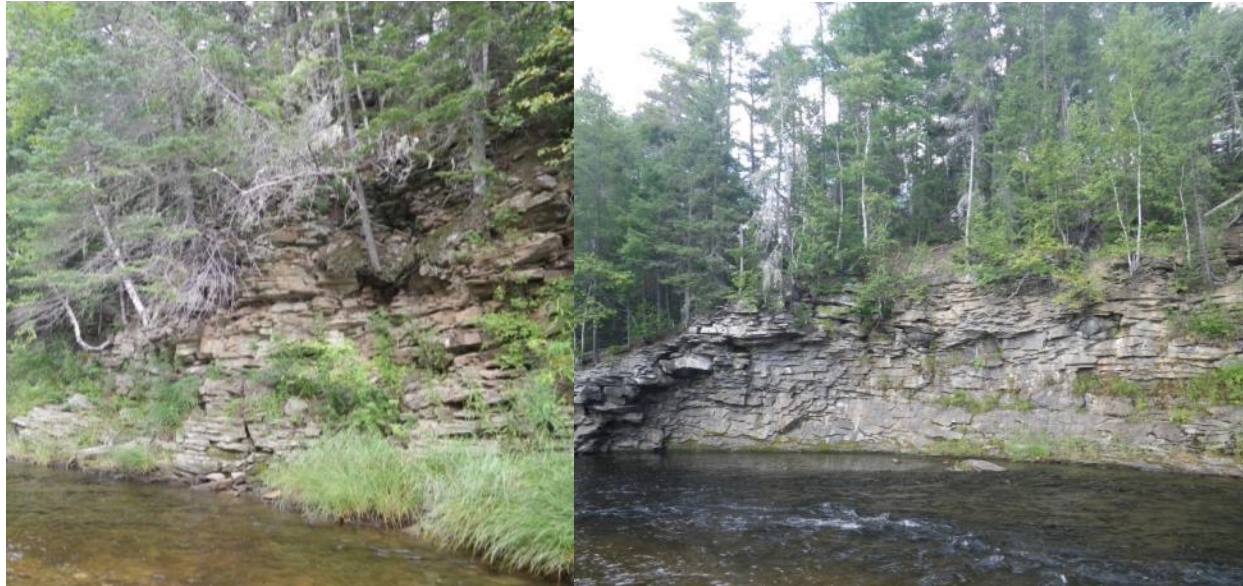
Figure 3-37: Exposed sedimentary bedrock in Reach 3 part 2: sub-reaches PS 2 54 (left); and PS 2 58 (right)

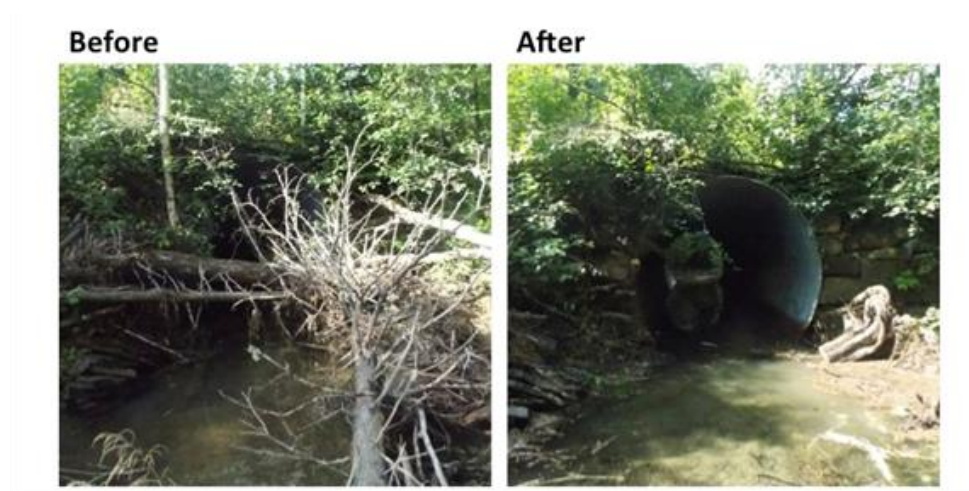
During the course of the 2014 culvert surveys, several candidates were identified for immediate action. Removing debris build-up is a simple and effective way of improving fish passage. All four debris removals were completed in the Pollett River basin. The first removal effort was conducted at the inflow of Culvert C012 (Figure 3-9) on Colpitts Brook. In order to improve fish access to approximately 7 km of upstream habitat in length and 31.43 km² in area, 3 trees were removed and placed above the high water mark (Figure 3-46).

Figure 3-46: Before and after photos of C012, located where Kaye Road crosses Colpitts Brook.

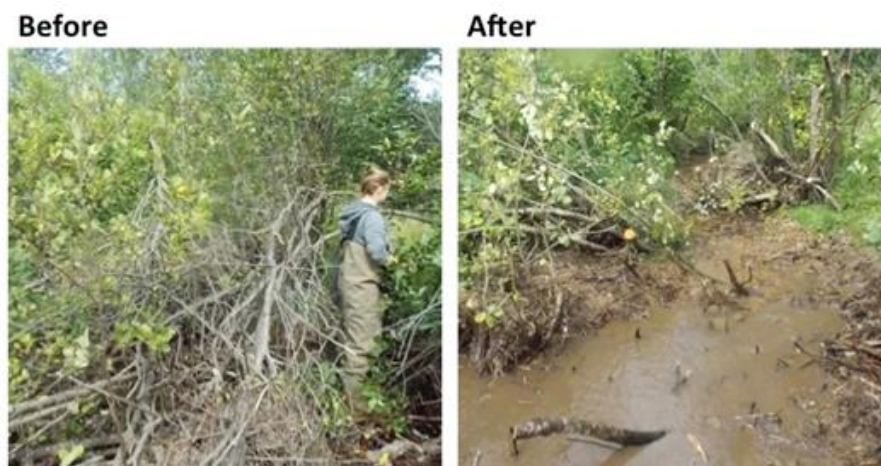
A second debris removal took place upstream of triple culvert C021-ABC, where willow growth had choked off the watercourse to the extent that it was scarcely visible (Figure 3-47). Willows were removed to enable fish passage to 6 km in length and 12.42 km² of upstream habitat

Figure 3-47: Before and after photos of culvert C021-ABC, where Church Hill Road intercepts Sheffer Brook.

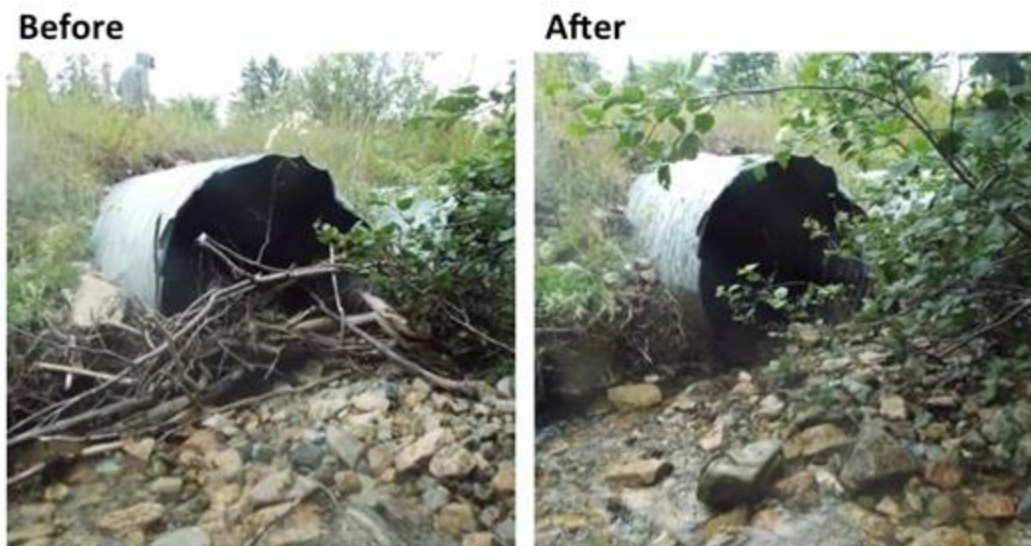
The third debris removal took place at culvert C022-ABC approximately 3 kilometers upstream of triple culvert C021-ABC. Debris build-up was removed from the inflow of the middle culvert (Figure 3-48), allowing fish improved access to 9.27 km² of upstream habitat.

Figure 3-48: Before and after photos of C022-ABC, located where Church Hill Road intercepts Sheffer Brook

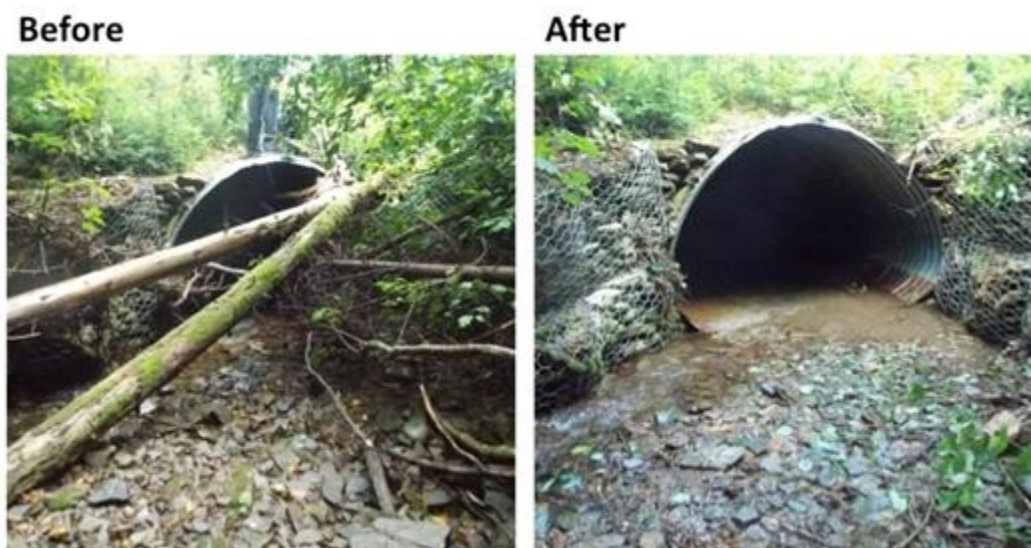
Two large trees were removed from the inflow of culvert C041, located where an Irving logging road intercepts the Popple-Intervale Brook. 7 km in length and 27.23 km² of upstream habitat was made more accessible for aquatic species.

Figure 3-49: Before and after photos of C041, where an Irving logging road crosses the Popple Intervale Brook.

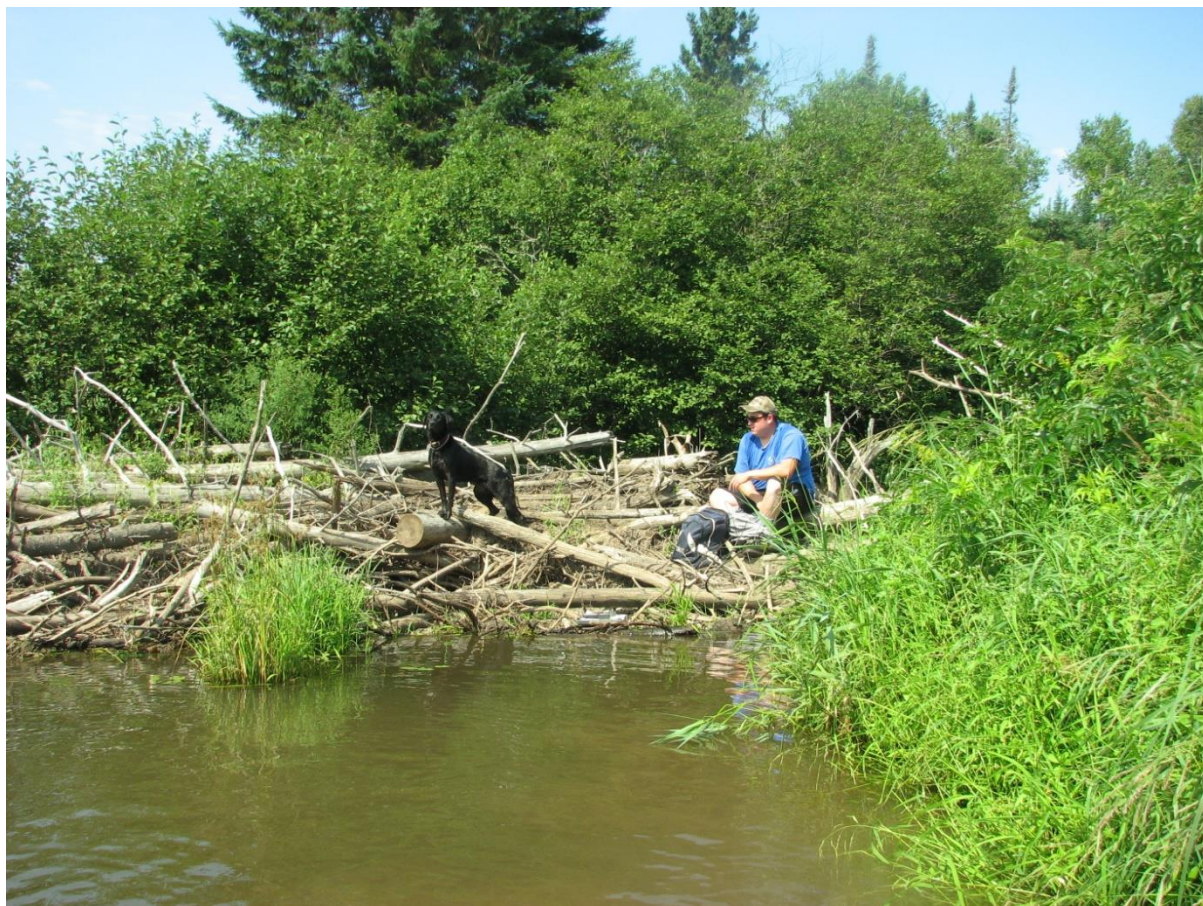
Figure 4-2: Log jam

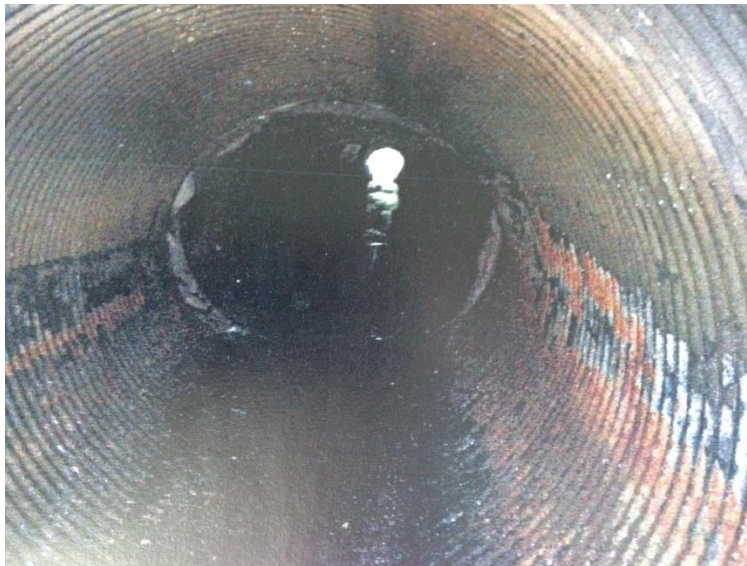
Figure 4-6: Culvert WM20.

The culvert WM20 is located under a two lane asphalt road on Route 126 at Control Section #R0126 009-9.550 (Figure 4-6). It was last inspected on August 13, 2012. There are two structures, a CSP component and a concrete arch. Both structure conditions are designated as FAIR to POOR. The following recommendations for this culvert are as follows:

- The vegetation on both sides of the road should be removed
- The debris and fill inside the culvert should be removed
- The scouring hole and the water drop should be eliminated
- The wheel ruts should be repaired
- The pipe sections that have separated should be repaired
- The undermining and erosion should be stopped and repaired
- A sign indicating the Culvert Number “WM20” should be stenciled on the guard rails over the culvert

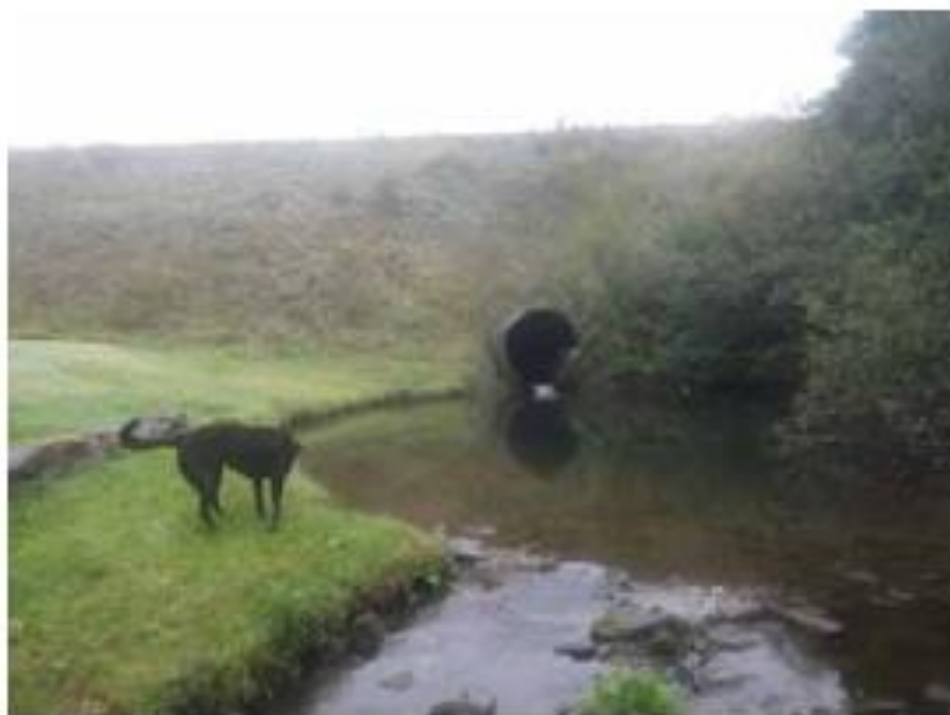
Figure 4-7: North River, plunge pool at Route 126.

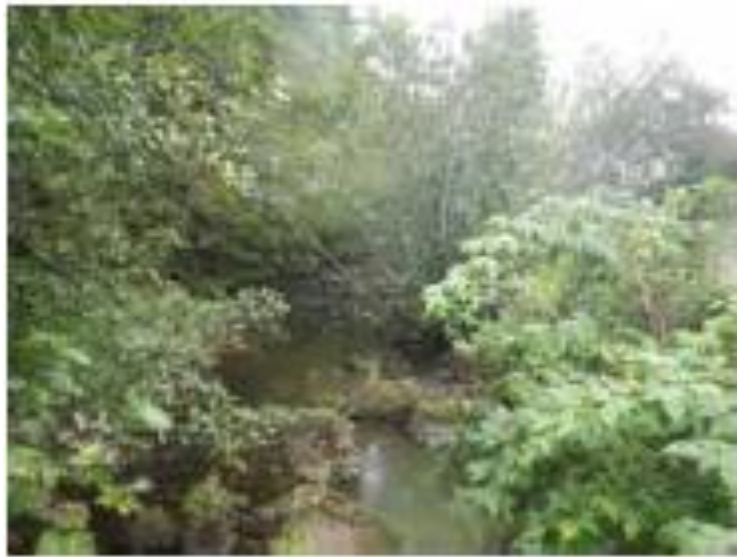
Figure 4-10: North River, alder cover.

With the dense alder cover in sub-reaches 6-0 to 6-3 (Figure 4-10), restoration efforts in these reaches would be difficult.

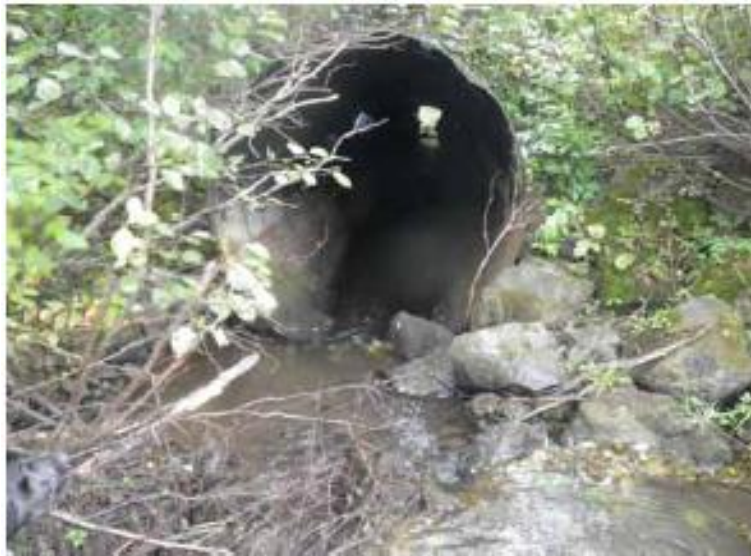
Figure 4-11: North River, Culvert under Rte 126.

If fish passage is a priority, the culvert under Route 126 is an issue with the downstream invert hanging above the streambed. The culvert appears to be able to handle the flows as the oxidization line on the pipe is approximately a third of the way up from the bottom (Figure 4-11). It is also noted that looking through the culvert, based on the photograph, the pipe may be collapsing. However, this could simply be the angle the photograph was taken and further investigation may be warranted.
